NAME OF THE INVESTMENT:	<b>REVITALISATION OF THE KING BASTION – A PART OF THE KOSTRZYN FORTRESS – FOR CULTURAL PURPOSES</b>	
ADDRESS:	<b>Bastion King, Zespół Fortyfikacji Twierdzy Kostrzyn, plot No. 75/3, K. nad Odrą</b>	
INVESTOR:	<b>City Kostrzyn nad Odrą, Ul. Graniczna 2 66-470 Kostrzyn nad Odrą</b>	
PHASE:	<b>ARCHITECTURAL RESEARCH REPORT</b>	28 February 2014
PREPARED BY:	<b>Janusz Nekanda-Trepka, MSc Eng architect</b>

## ARCHITECTURAL RESEARCH REPORT

## I. TECHNICAL CONDITION ASSESSMENT

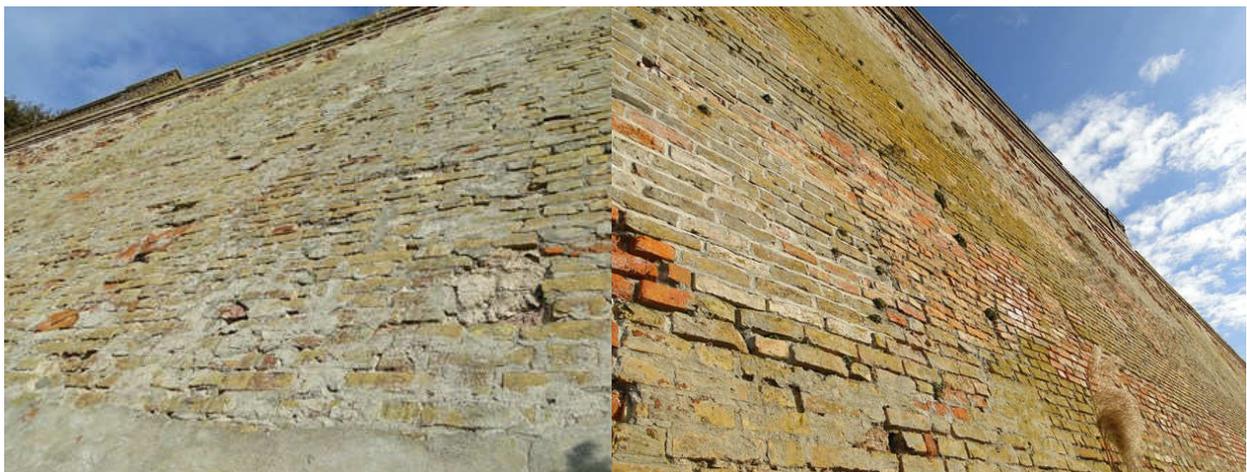
The walls above the existing terrain from the side of the Oder River were built of bricks, on lime mortar, with a neat and uniform bond. The curtain walls at the site of contact with the soil is protected against direct impact of the river water, a band of reinforced concrete offset by about 40cm, the depth of the foundation has not been specified. The top layer of bricks (the face of the wall) with strongly corroded brick.

In places where the wall is covered with cement plaster with greater resistance than the original material, there are numerous scaling spots, causing the brick corrosion and grout loss. The corrosion of the wall face is so strong that the bricks crumble when touched. Some of the cracks visible in the walls were caused by warfare operations. In several places the walls have been repaired with the use of a material incompatible with the original material. The process causing the acceleration of the wall corrosion is also the locally overgrown vegetation. The wall crown has been rebuilt and covered with a reinforced concrete ring to which the railing is attached. Despite numerous defects of the bricks and the mortar as well as local cracks in the face layer of the walls, the overall technical condition of the walls is defined as good. Most of the visible damage, including local cracks, are not dangerous for the stability and the future existence of the structure. The causes of many of the aforementioned defects are caused by long-term weather impact along with insufficient protection of the facility and wrong choice of protective materials. The basements of the bastion and the curtain walls are exposed to the direct impact of the water from the Oder River and the moat.

Photo 1,2 Top layer of bricks (the face of the wall), covered with cement plaster with clear corrosion of bricks

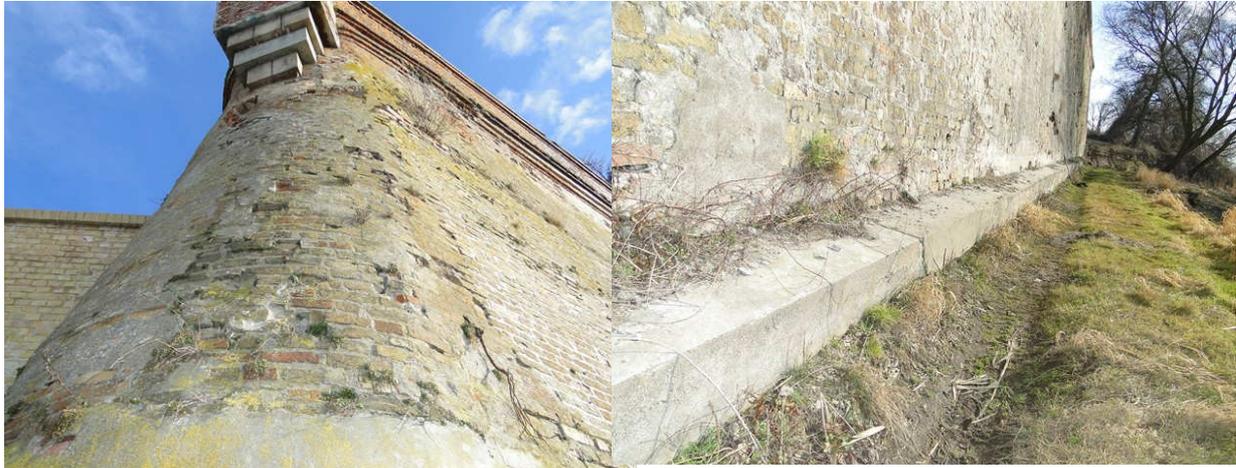
Photo 3 View of biological corrosion of the wall bricks in the area of the moat

Photo 4 View of the reinforced concrete band, partially offset by about 40cm

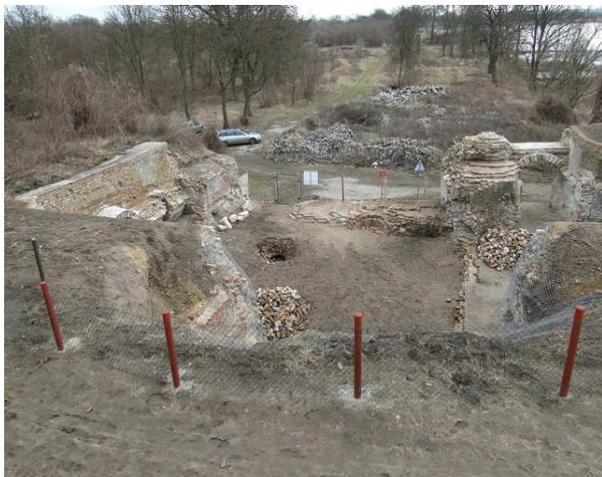
Photo 5 View of the southern barge from the level of cavalier terrace

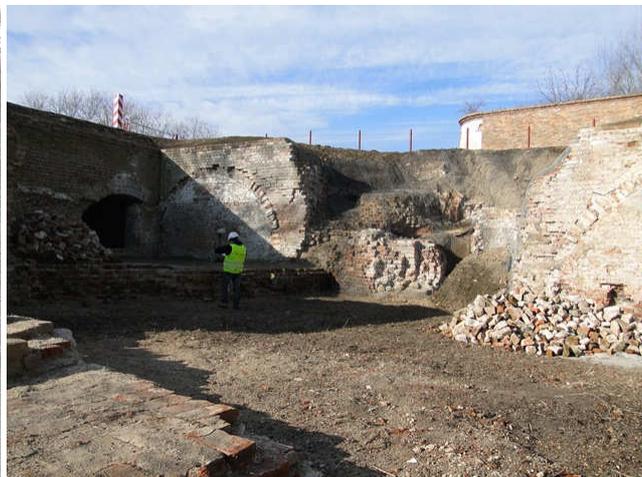
Photo 6 View of the southern barge from the level of the existing embankment

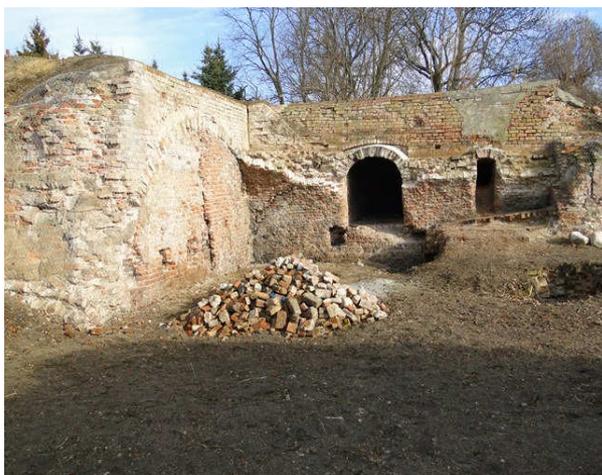
Photo 7 View of the wall remains of the southern barge

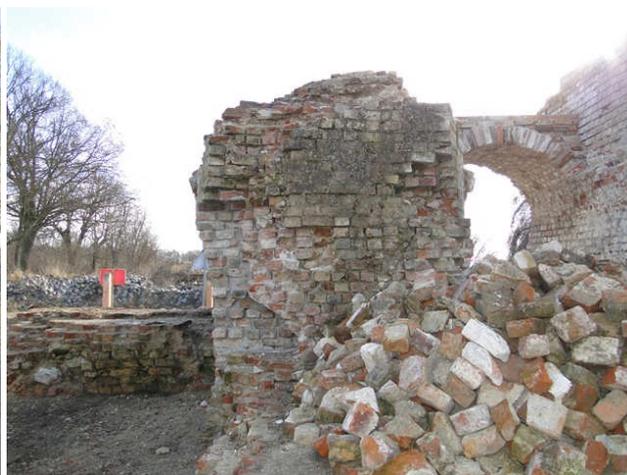
Photo 8 View of a fragment of the curtain wall remains

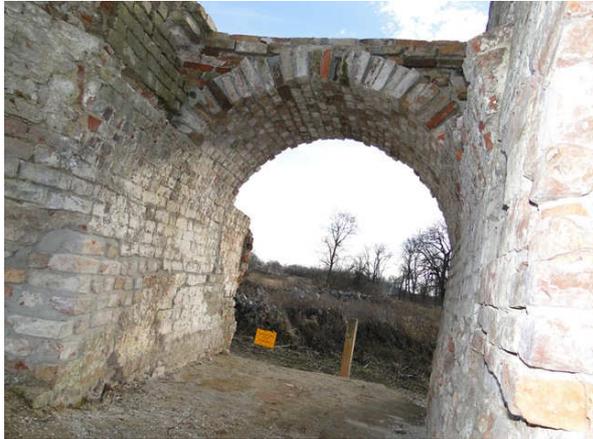
Due to the poor technical condition, and the threat of collapse of the vault remains at the front wall of the barge, the vault was demolished and constructed again, maintaining the original shape. Crowns of the walls were reconstruct with the use of solid brick recovered during the pit works. The works were performed in order to maintain the condition of the existing facility, before it is possible to carry out conservation operations.

Photo 9 View of the repaired vault at the front wall of the barge from the inside

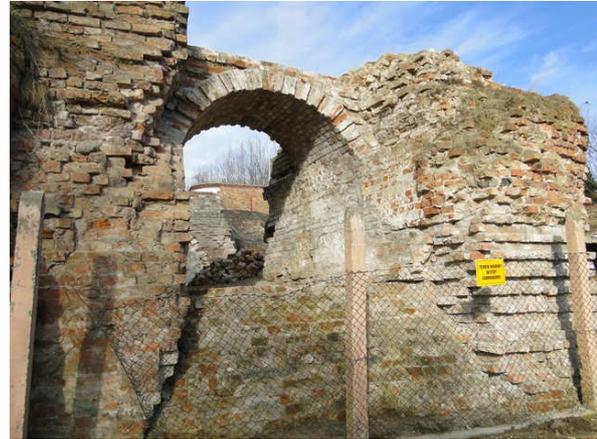
Photo 10 View of the repaired vault at the front wall of the barge from the outside

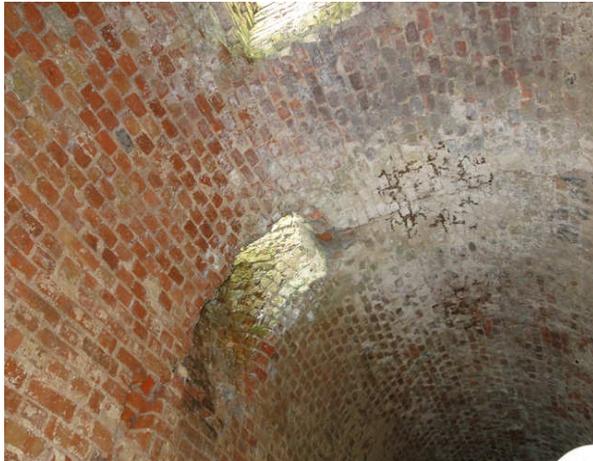
Photo 11 View of the vault of the casemates in the area of ventilation openings

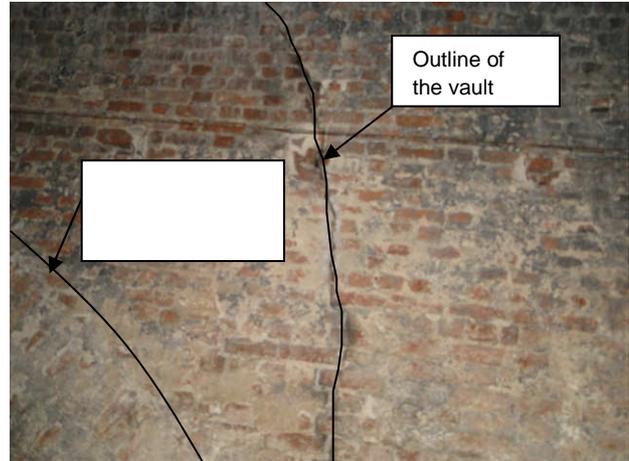
Photo 12 View of the cracked wall in the area of the arc reinforcing the wall of the casemates

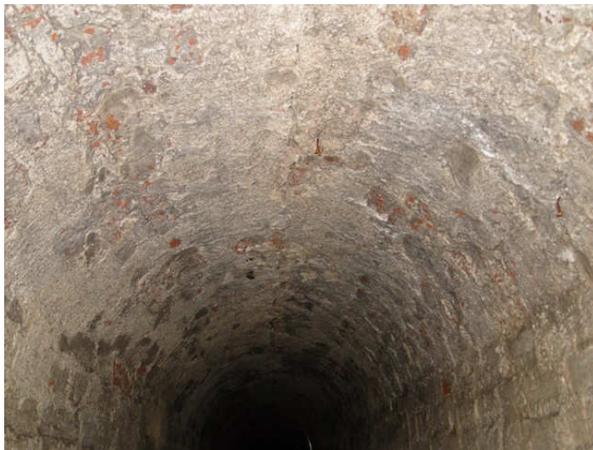
Photo 13 View of the vault lined with plaster

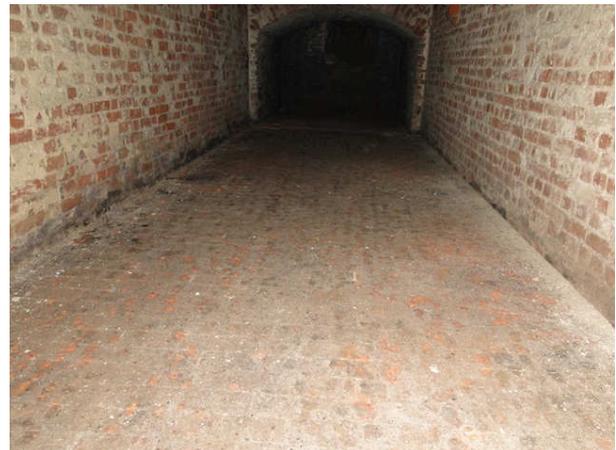
Photo 14 View of the floor with traces of condensate water

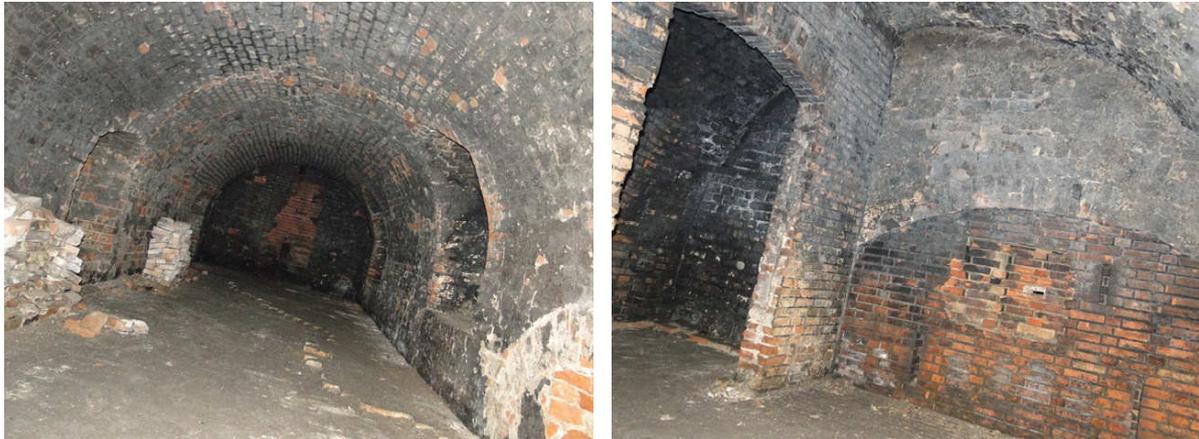
Photo 15 View of the casemates vault painted with tar

Photo 16 View of filler wall structure

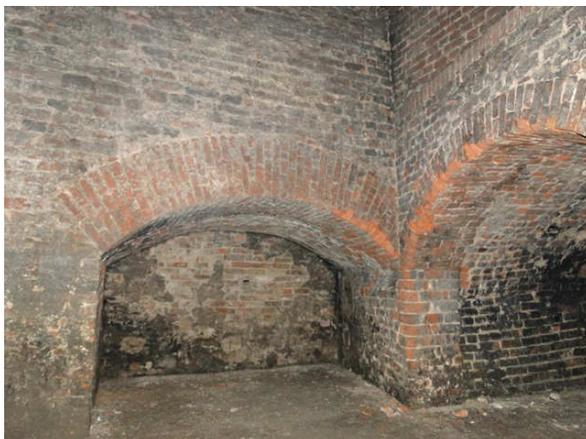
Photo 17 View of the arch beams performed in the form of a single layer and two layers of bricks laid vertically

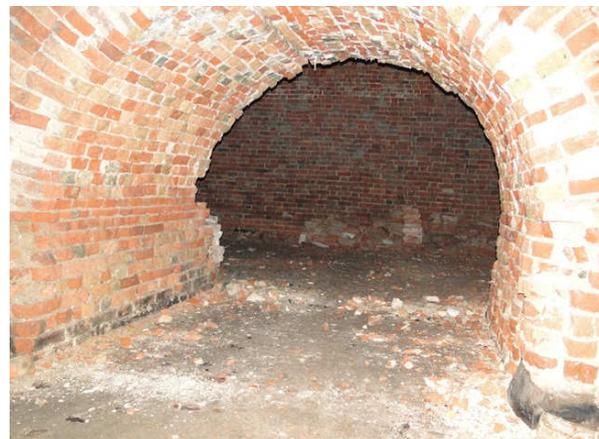
Photo 18 View of the arched vault between the casemates, with numerous defects in the bricks

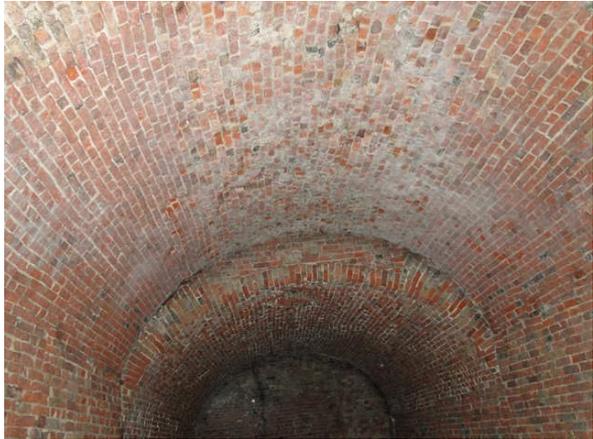
Photo 19 View of the overlapping vaults from the inside of the casemates

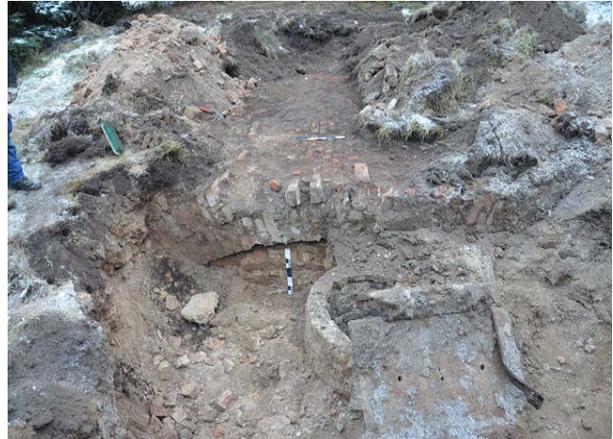
Photo 20 View of the step on the vaults of the casemates from the outside

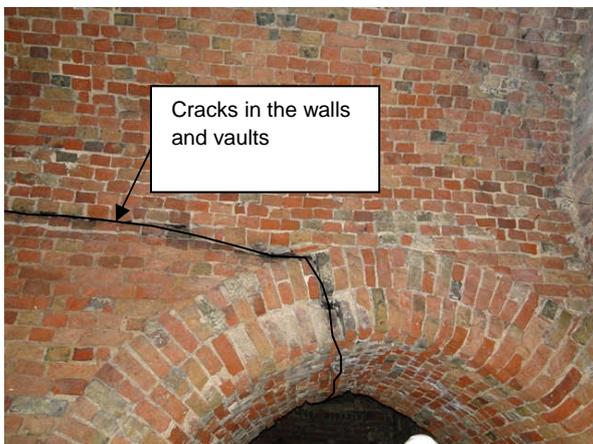
Photo 21 View of the cracks in the walls and the vault over the entire width of the wall

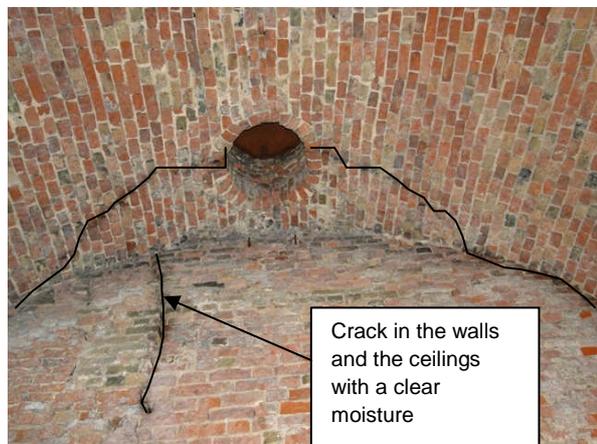
Photo 22 View of damp cracks in the area of the casing

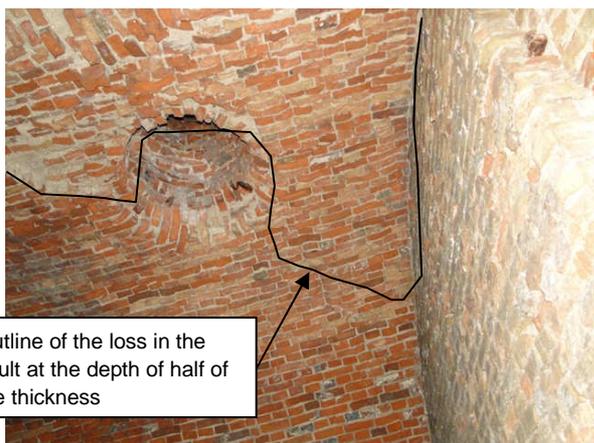
The ceiling over casemates (-2.15) is definitely in the worst condition, and the losses found there reach half of the ceiling thickness. Due to high humidity, the bricks of the vault are brittle, with a visible decomposition of the brick structure. The ceiling is covered with a layer of soil of about 200cm. Observations inside the casemates have confirmed that the technical condition of the ceiling varies. A large slenderness of the structure in the area of extensive damage suggests an impending failure or damage of the structure. The lack of ceiling protection may cause further corrosion and loss of

Photo 23 View of the vault loss at half the thickness in the area of the ventilation opening

Due to numerous losses in the ceiling and strong corrosion of the bricks, the solution of reinforcing the vault with the use of the spraying method (concrete spraying) will not meet its purpose also in this case. This method requires a properly prepared substrate, which is not possible in the case of such strong corrosion of the bricks. The vault must be level and free of loose fragments.

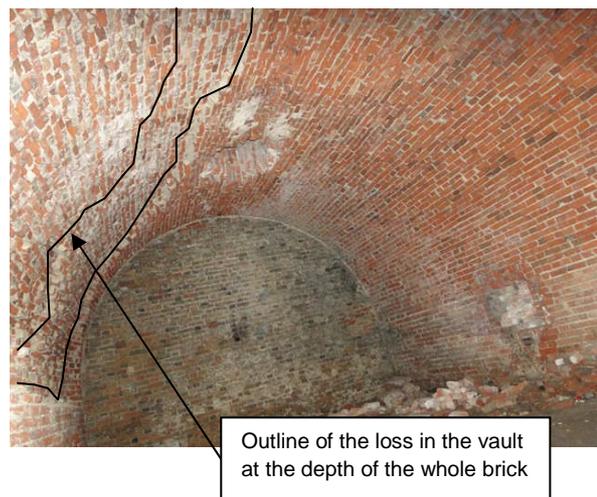
Photo 24 View of the ceiling loss in the area of the walls

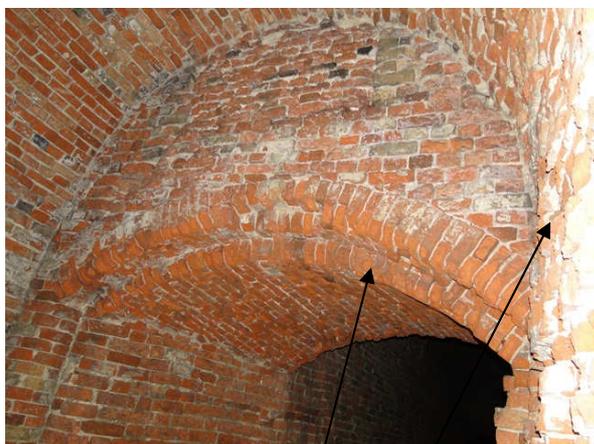
Photo 25 View of the vault loss and mineralised brick in the wall

Photo 26 View of the brick loss at the connection of the walls with the vault

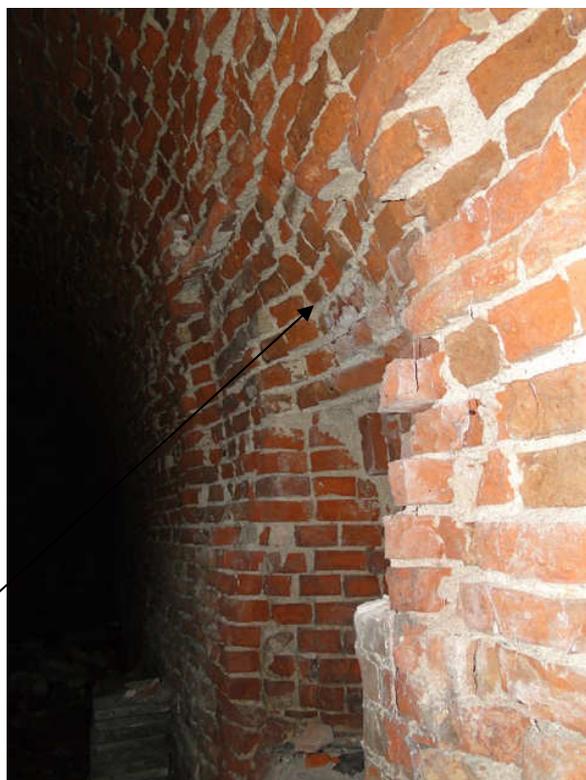
Loss of bricks in the vault

View of mineralised brick on the wall

View of the brick loss at the connection of walls with the vault

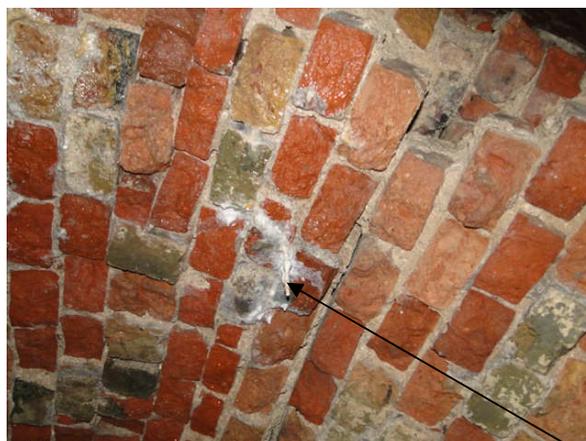
Photo 27 View of the salt efflorescence on the vault, occurring as a result of precipitation water penetration and high air humidity.

- elimination of salt efflorescence on walls and ceiling vaults
- gaps and significant cracks should be fastened with stainless steel anchors or connect with a system of brick walls.

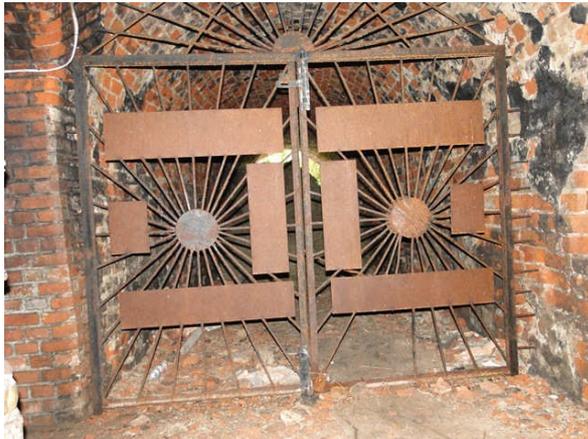
Photo 28 View of corroded steel elements

In the casemates, all the metal elements, such as doors or hooks are significantly corroded due to high air humidity.
